**NAWS CHINA LAKE
MOHAVE TUI CHUB
PROGRESS REPORT
for
2005 - 2006**

Prepared for:
The Environmental Planning and Management Department
Code N45NCW, China Lake

January 2007

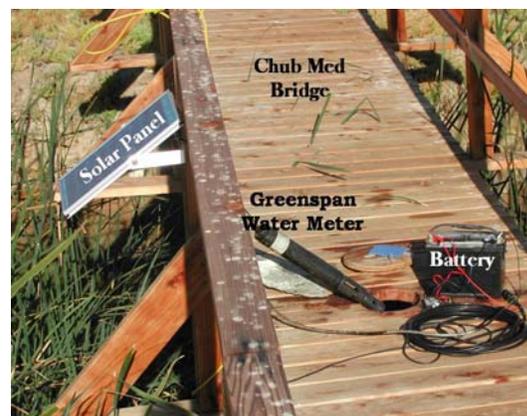
Figure 2: Greenspan Water Meter

Monitoring the water parameters of pH, dissolved oxygen (DO), temperature and conductivity is an on-going project. The Greenspan CS304 meters (Figure 2), placed at the Mystery Culvert and Chub Med in the North Channel, and in the G1 Channel, record data every 30 minutes 24 hours daily. This year, the meters along the North Channel had problems with animal chewing and required repair. The Chub Med meter had to be sent into the Stevens Water Monitoring Systems company for repairs and calibration and was not returned for three months.

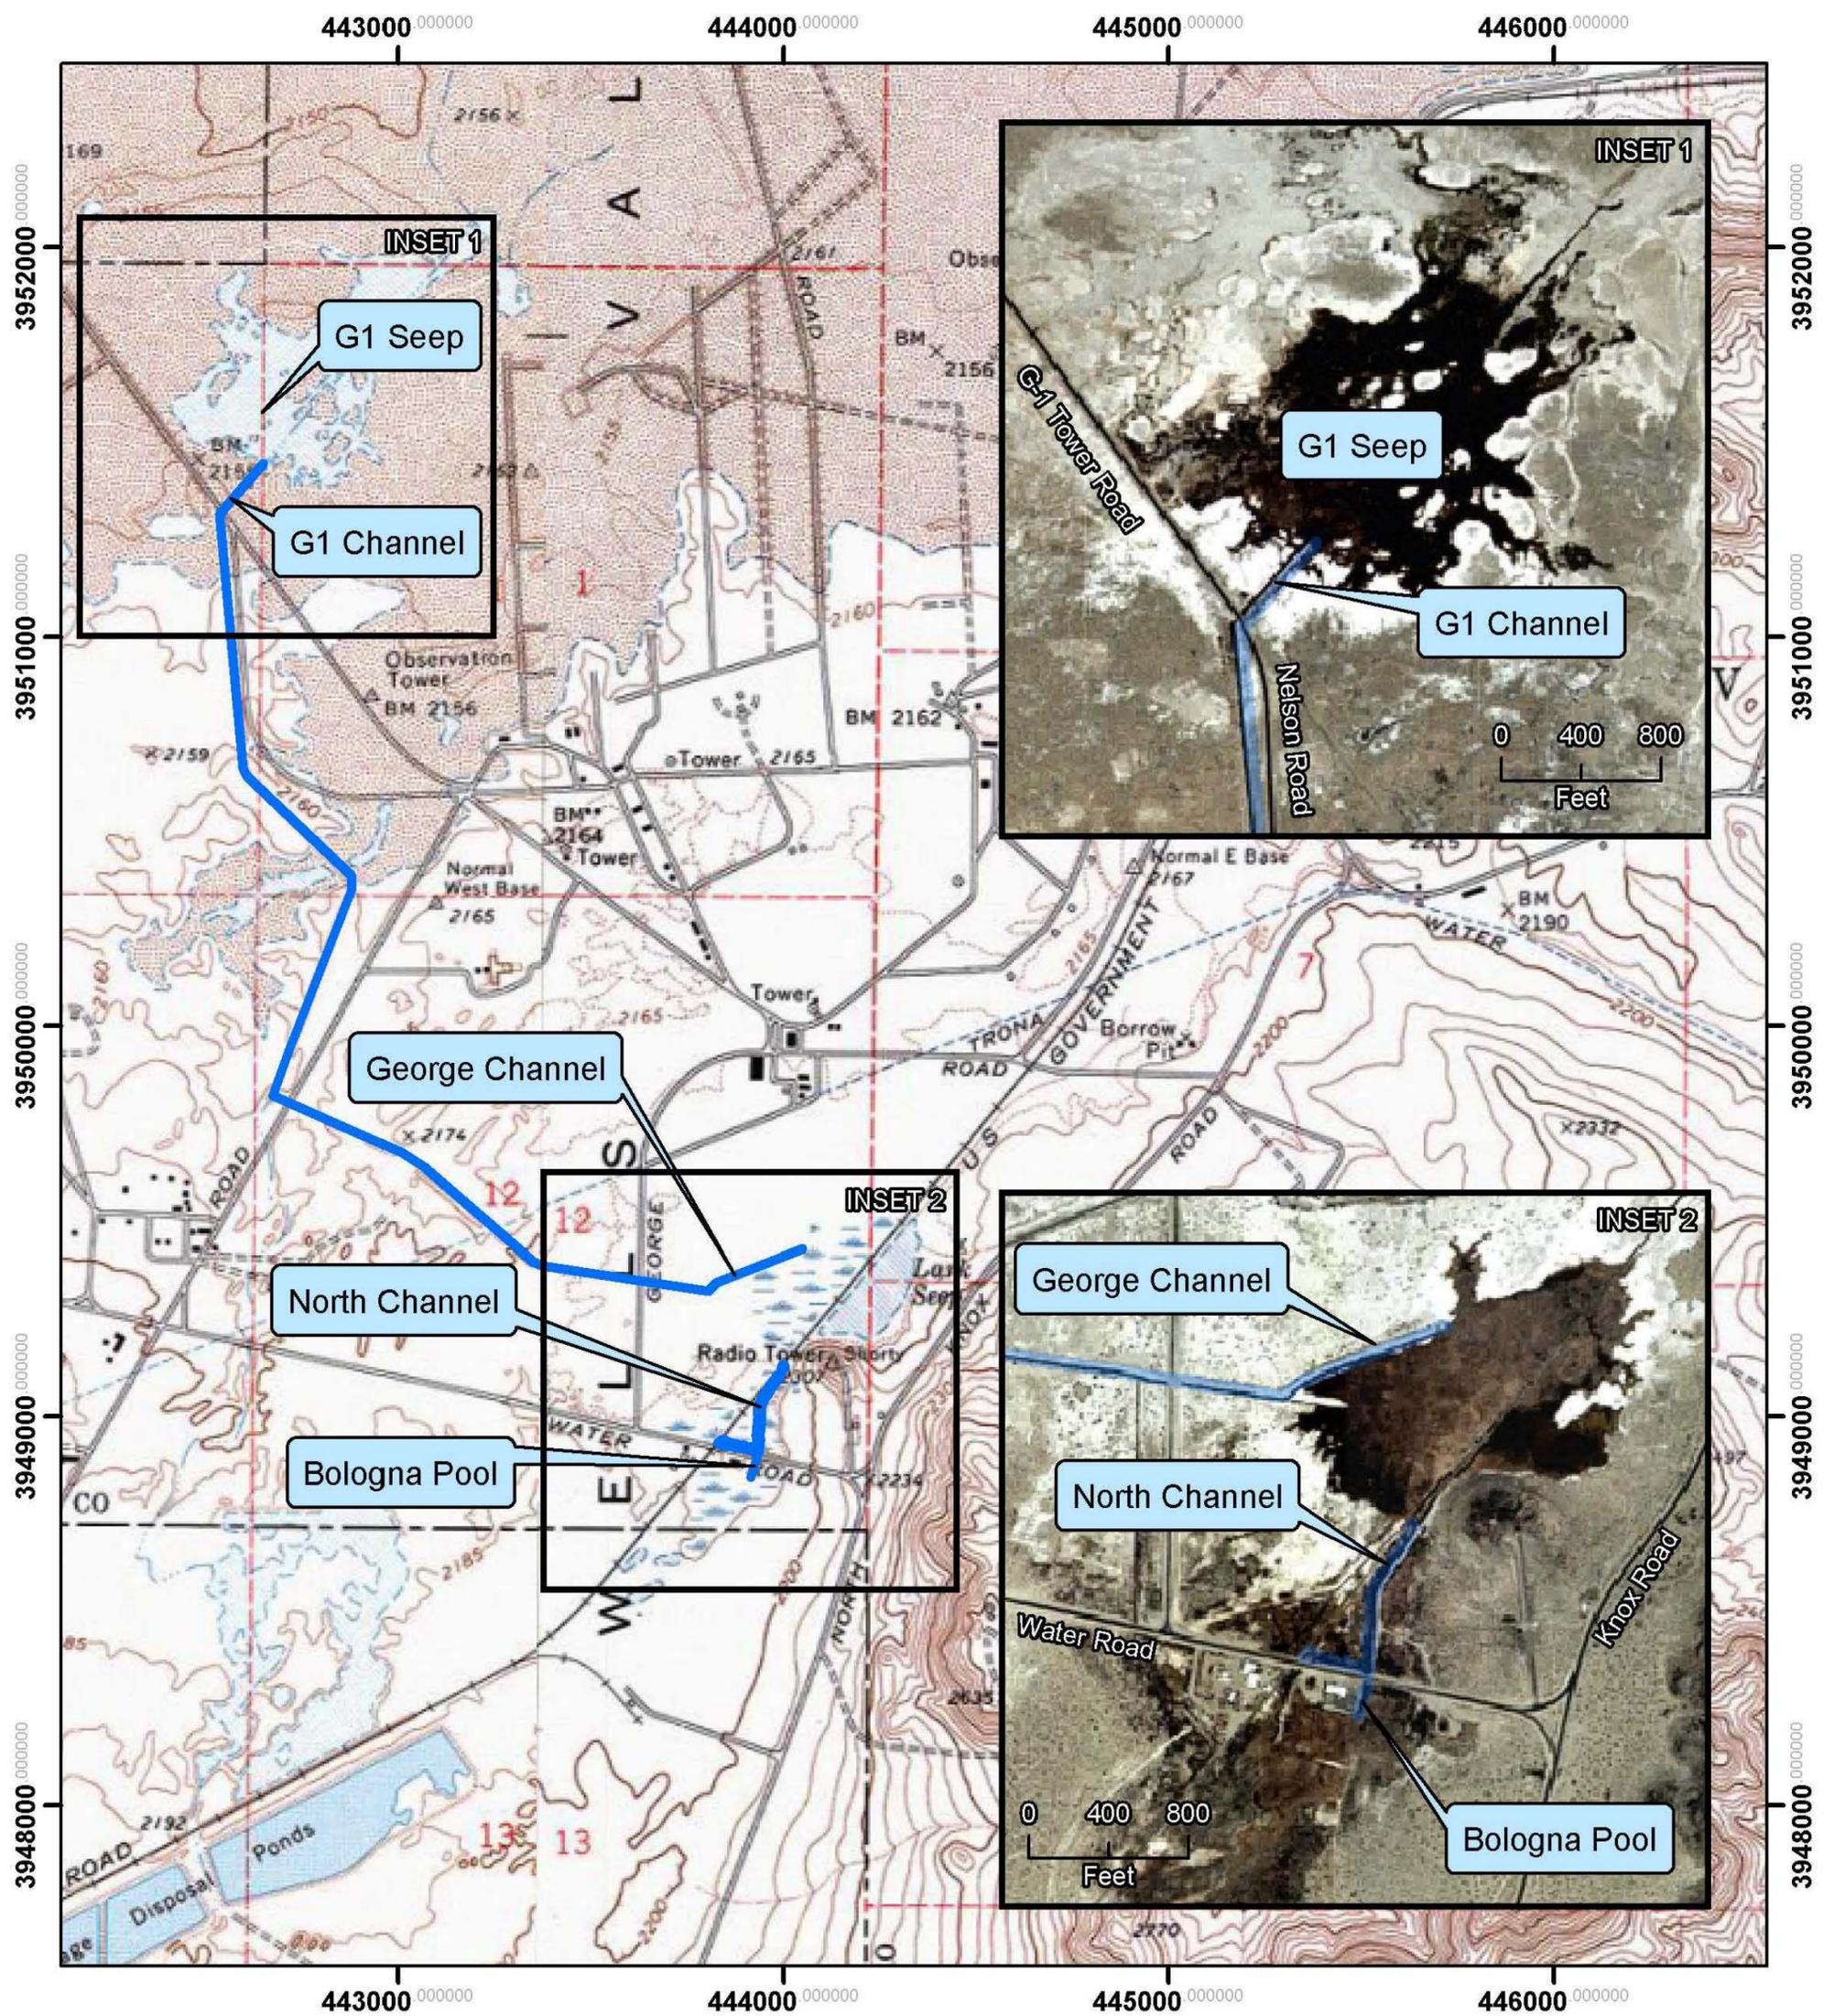
Figure 1: Lark Seep System, NAWS China Lake

The City of Ridgecrest's Waste Water Treatment Facility (WWTF) evaporation and percolation ponds, existing on the NAWSCL since 1945, elevated the already high groundwater mound and resulted in the establishment of Lark Seep. In order to control the expansion of Lark Seep, and to encourage water to flow away from nearby structures and test sites, a system of channels was created. The channels direct the day-lighting groundwater away from NAWSCL facilities northward to the China Lake playa, where G1 Seep formed. This network of channels and seeps is referred to as the Lark Seep System (Figure 1).

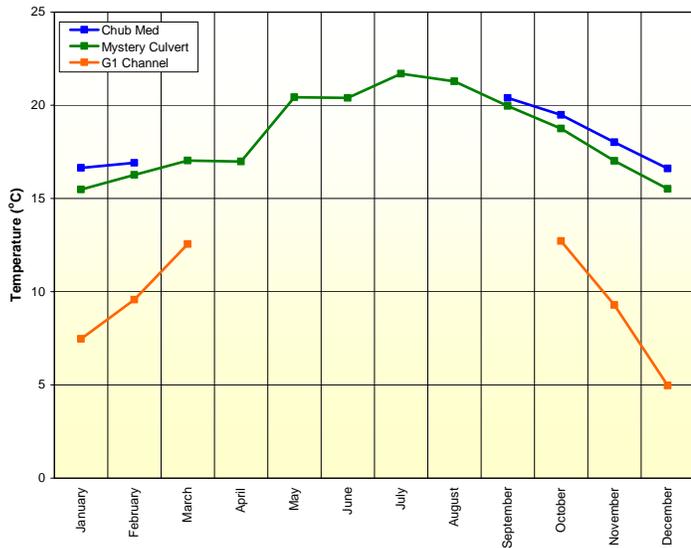
Figure 3: 2005 Monthly average temperature for each water meter position.

Figure 3 indicates that water temperatures in the North Channel at the Mystery Culvert do not greatly vary. Chub Med data is not continuous due to meter probe failures and repair time. Data for the G1 Channel is not complete due to computer download problems.

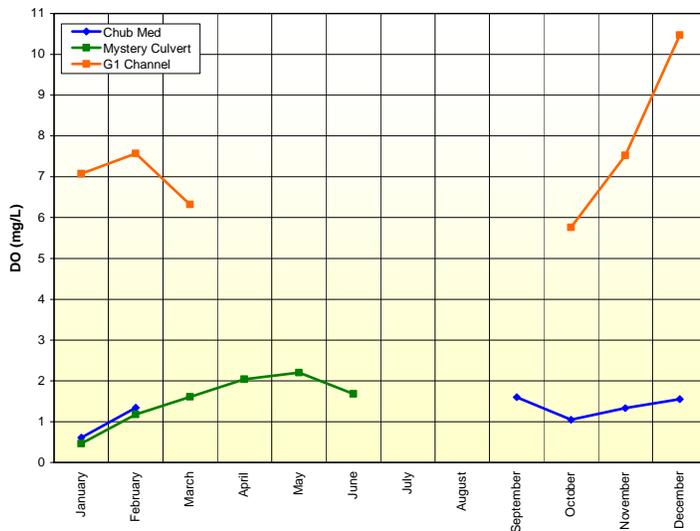
Figure 4: 2005 Monthly average dissolved oxygen for each water meter position.

Figure 4 data is segmented due to computer download problems and meter malfunctions. The data gathered indicates that DO in the G1 channel is significantly higher than in the North Channel.

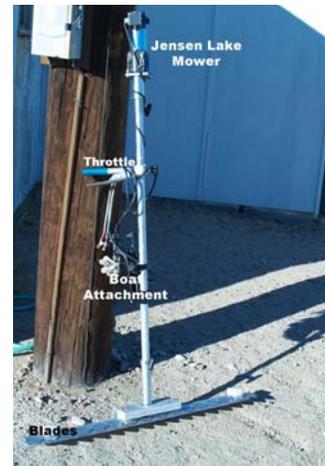
Figure 5: Jensen Lake Mower

In 2004 cattails were only removed within the North Channel utilizing the Jensen Lake Mower (Figure 5). When cattails were cut with the mower, overall water clarity was higher than when cattails were mechanically removed. Other channels were considered for cattail removal with the lake mower; however, access issues precluded the use of the mower in those areas.

Mechanical removal of all cattails within the North Channel was accomplished in the fall of 2006 and water clarity decreased (as per personal observation). It is believed that water clarity is tied to DO levels. Therefore, all future cattail removal should be accomplished with the Jensen Lake Mower to enhance water clarity and DO. Cattails should be cut monthly to keep them within manageable levels.

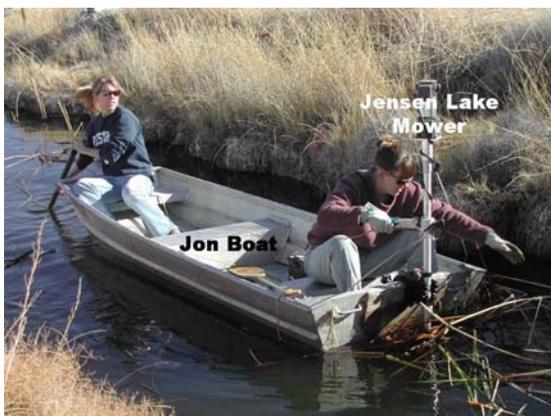
Figure 6: Mower attached to boat.

Cattails have been removed utilizing a Jensen Lake Mower attached to a ten foot Jon Boat (Figure 6). There is not enough clearance under the bridges for the mower to fit (Figure 7). In order to proceed under the bridge, the mower must be folded back. In the process of cattail removal in the fall of 2005, while lowering the mower to pass under a bridge, the main attachment piece broke. This piece not only allows attachment to the boat, but also holds the cutting blades at a specific level under the water. During the period while this part was ordered for replacement, the cattails grew too thick for mower removal.

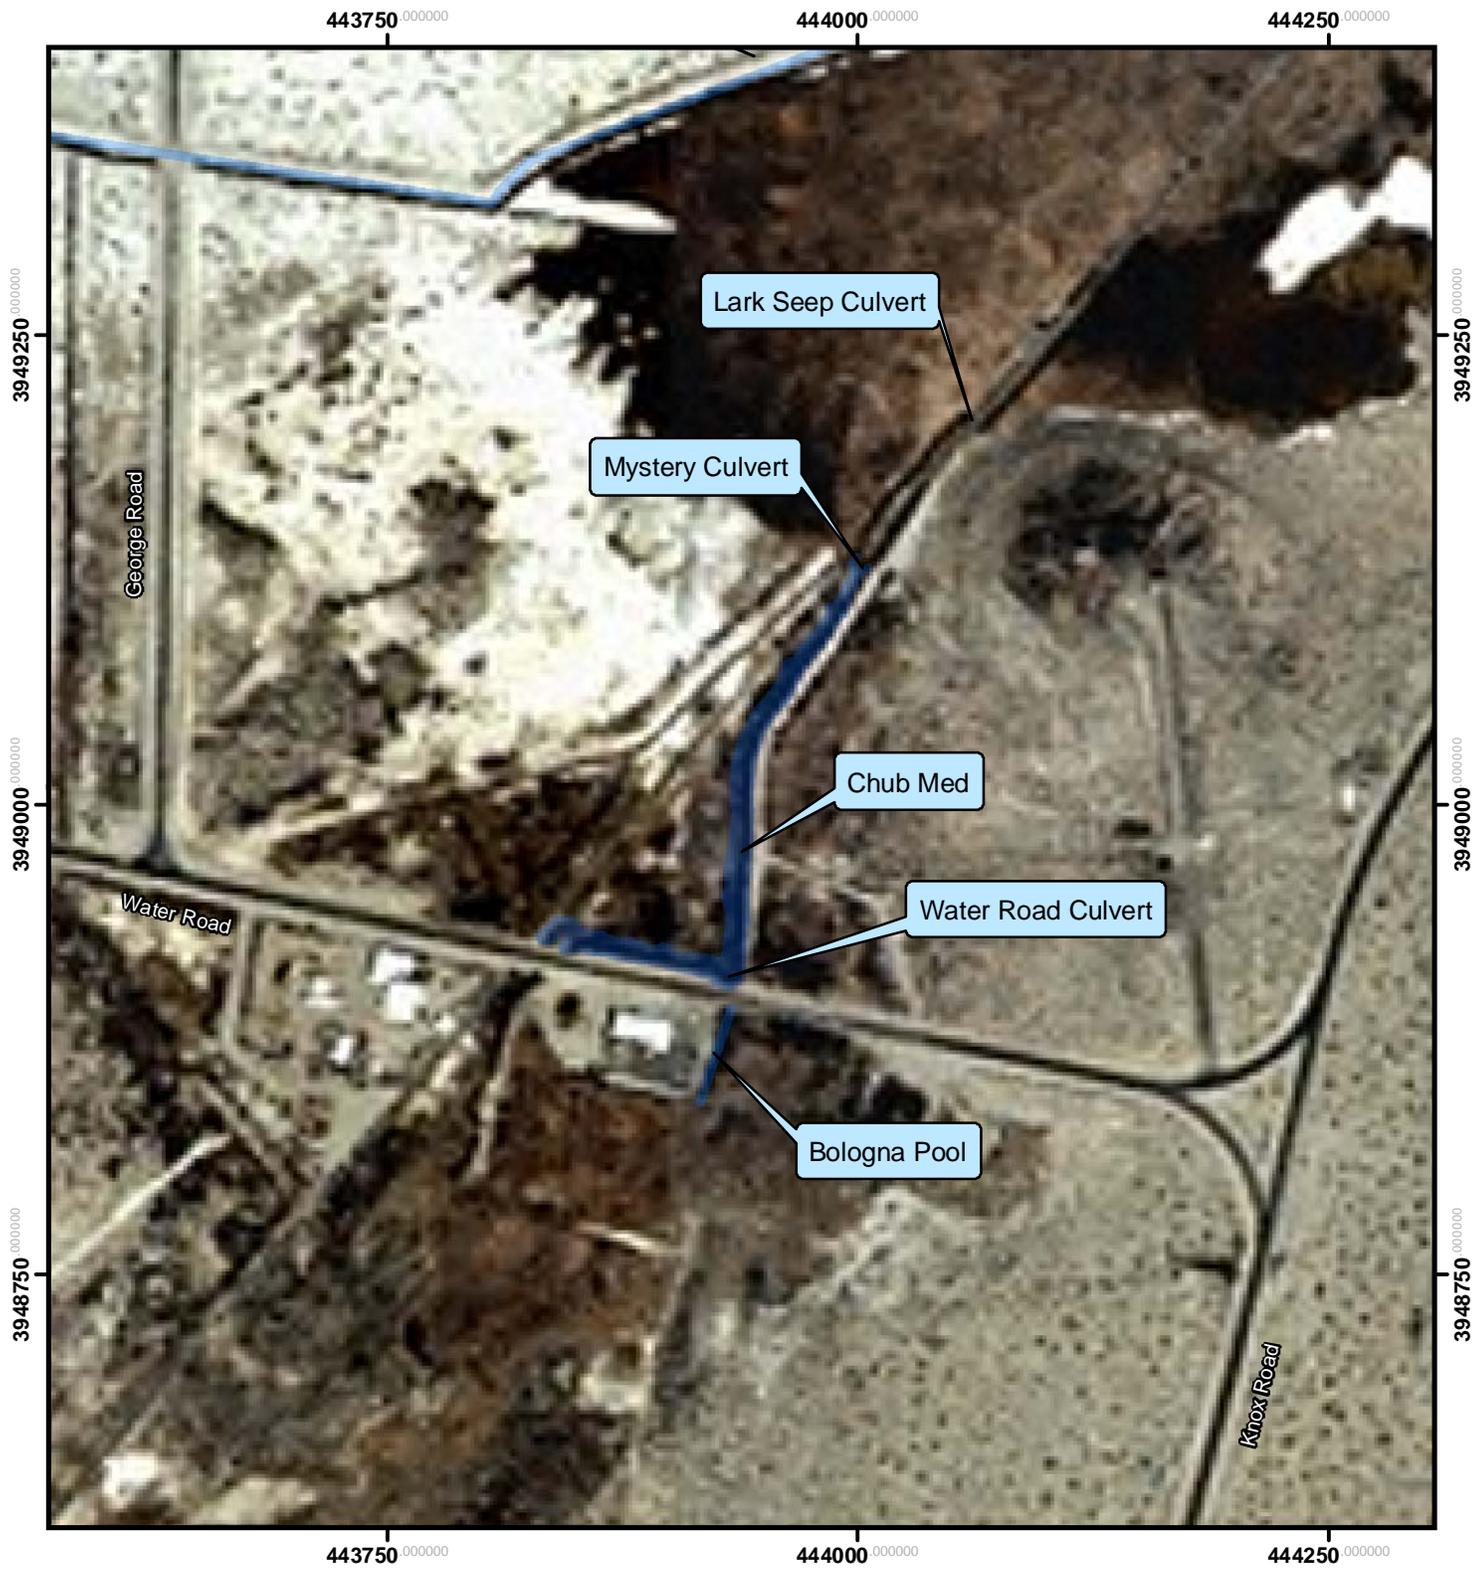
Figure 8: Lark Seep System, North Channel

In August 2005, the water level in Lark Seep was receding. In the past, water levels were restored when cattails were removed from along the west side of the railroad bed to the Lark Seep Culvert (Figure 8). On 20 September 2005, mechanical removal of cattails from the Mystery Culvert to Lark Seep Culvert, both sides of the Water Road Culvert, and throughout George Channel commenced in compliance with USFWS biological opinion 1-8-97-F-39R.

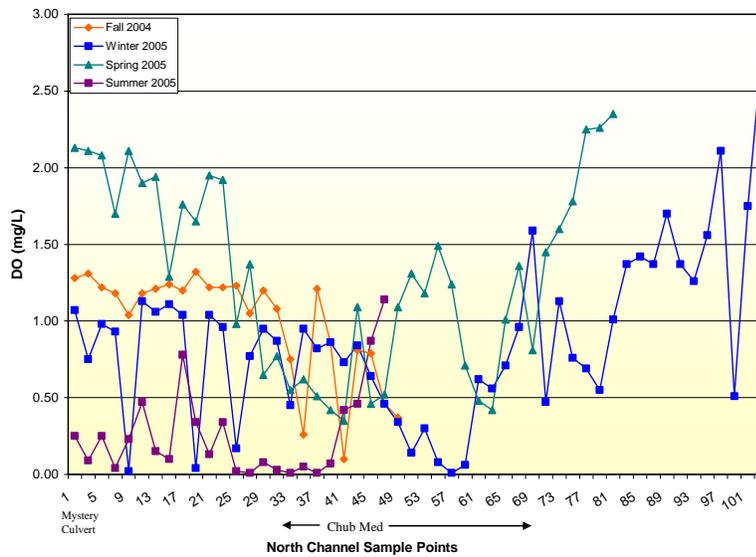
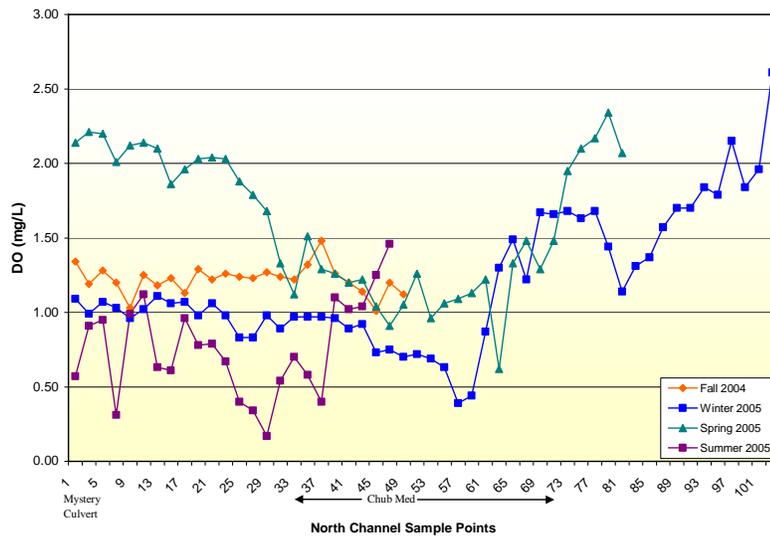
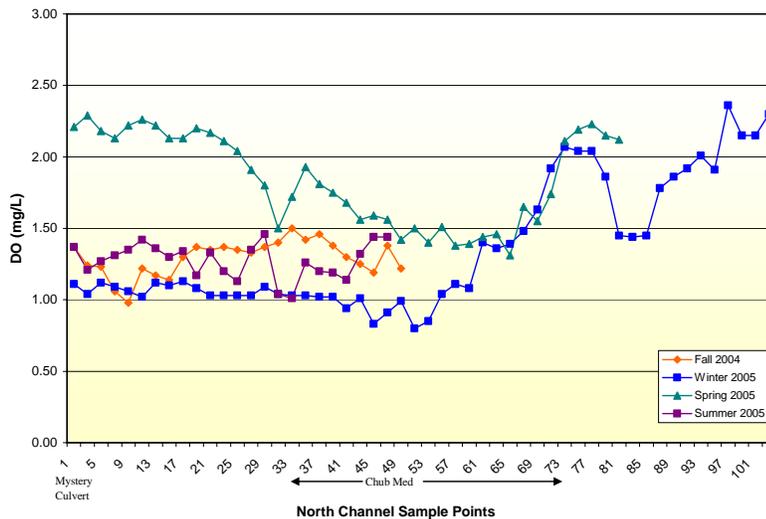
Figure 9: 2005 dissolved oxygen values in the bottom column of the North Channel.

Figure 10: 2005 dissolved oxygen values in the middle column of the North Channel.

Figure 11: 2005 dissolved oxygen values in the top column of the North Channel.

The 2005 dissolved oxygen study results indicate that DO levels throughout the channel are low (Figures 9-11). DO levels at Lake Tuendae in Zzyzx, California average around 10 ppm. The best DO values occur in the spring; however, that is when chub spawn so a population survey may not be conducted during this timeframe. The next best DO levels occur in the fall. The fall is when ambient temperatures are dropping but the water temperatures are still high enough for the fish to be active, making it an acceptable time to conduct a population survey. The fall and summer data sets are short due to cattail overgrowth. It is unknown why the highest DO values

are in the western 'L' section (points 81-103) of the North Channel. The water is very shallow in this section and fish have not been observed in this area, therefore, monitoring of DO in this area was discontinued as a result of these observations.

Historically traps have been placed on the bottom of the channel. The results indicate that trap placement should be in the middle of the water column, as DO levels are higher and more stable at that level.

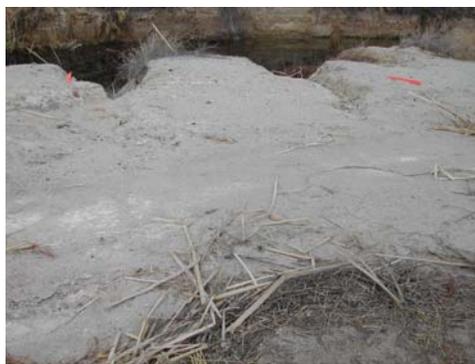
Figure 12: Erosion of North Channel Road.

The North Channel Access Road has begun to erode (Figure 12). The erosion of the road has resulted in problems with access in order to complete DO and cattail removal projects. Plans are being drafted to utilize the abandoned railroad bed to the west of the channel for future access. The USFWS is being consulted for this project.

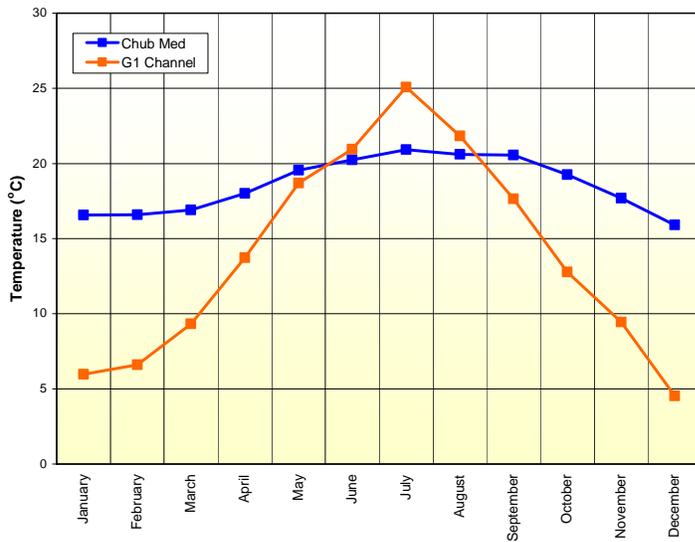
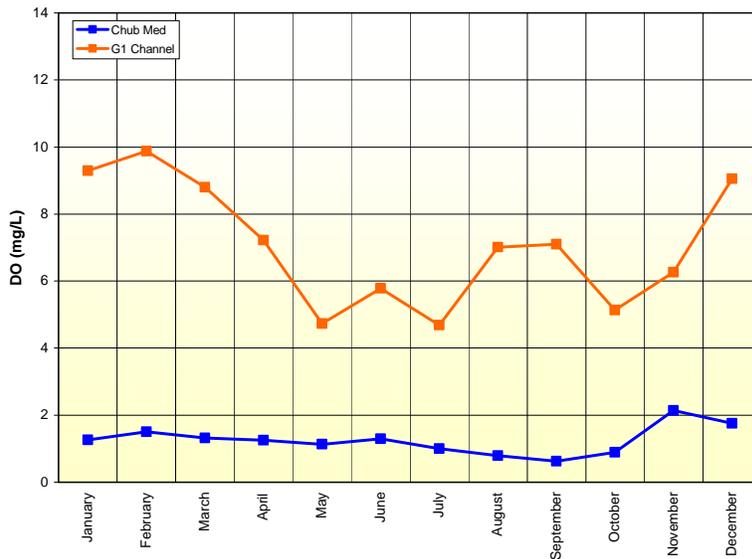
Figure 13: 2006 Monthly average temperature values for Chub Med and G1 Channel.

Figure 14: 2006 Monthly average dissolved oxygen values for Chub Med and G1 Channel.

At Chub Med the temperatures remain relatively stable but the DO is low (Figures 13-14). The dissolved oxygen at the G1 Channel is much higher than the North Channel.

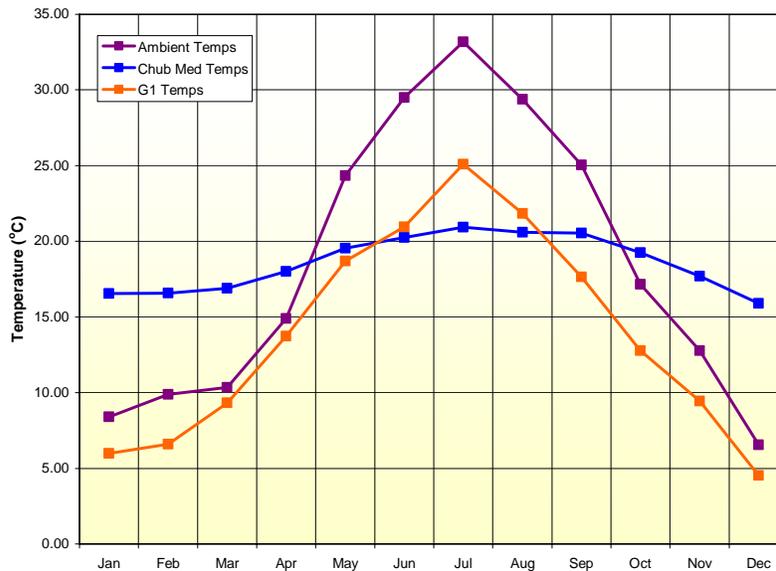
Figure 15: 2006 Ambient temperatures vs Chub Med and G1 water temperatures.

Temperatures at the G1 Channel appear to change according to ambient air temperatures (Figure 15). Ambient air temperatures appear to influence water temperatures in areas with lower water levels.

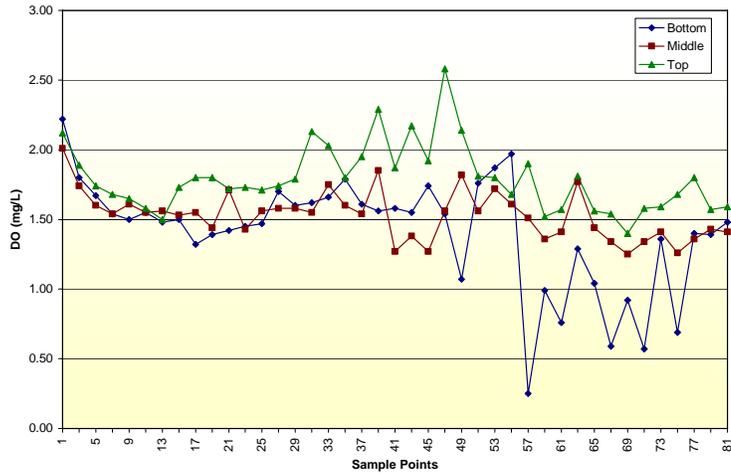
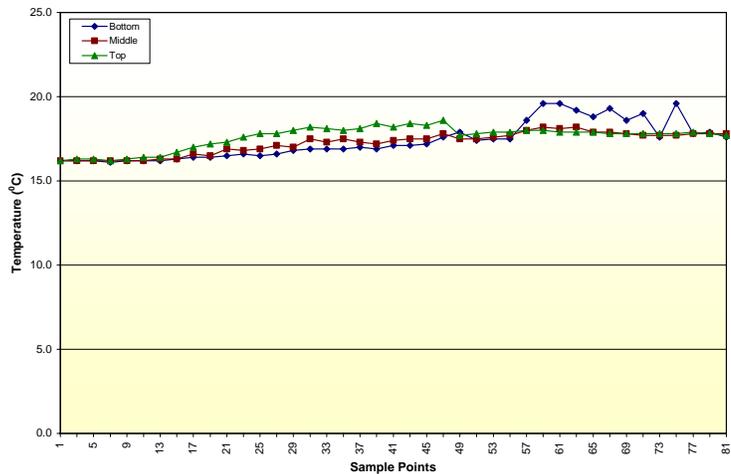
Figure 16: Fall 2006 North Channel dissolved oxygen study results.

Figure 17: 2006 North Channel fall temperature results.

Figures 16-17 are the results of the data gathered in October. Dissolved oxygen in the bottom of the water column, especially in Chub Med, is low. Temperatures are stable throughout the columns of water.

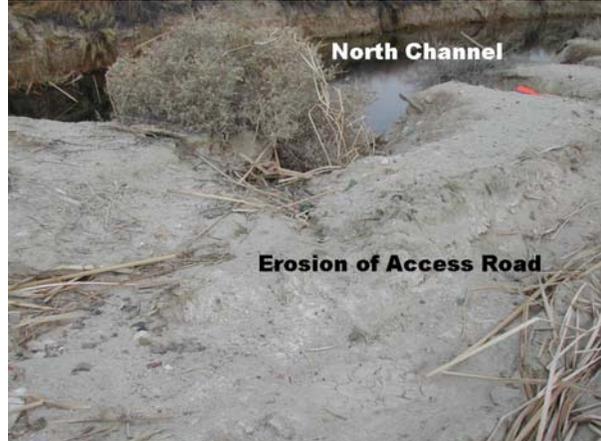
Figure 18: Erosion of North Channel access road.

Access along the North Channel has become more challenging throughout the years. The water surface along most of the channel is between 6-10 feet lower than the road. The Mystery Culvert, which is at the end of the access road, is the only place where the boat can be placed into the North Channel. However, winter storms have caused higher occurrences of erosion along the road making it difficult to gain access to the channel (Figure 18). Alternative methods of access needed to be developed. After research and discussion with NAWSCCL planners and construction crews, it was decided that the abandoned railroad bed would make a good alternative, but there would have to be additional roads made for access directly to the channel.

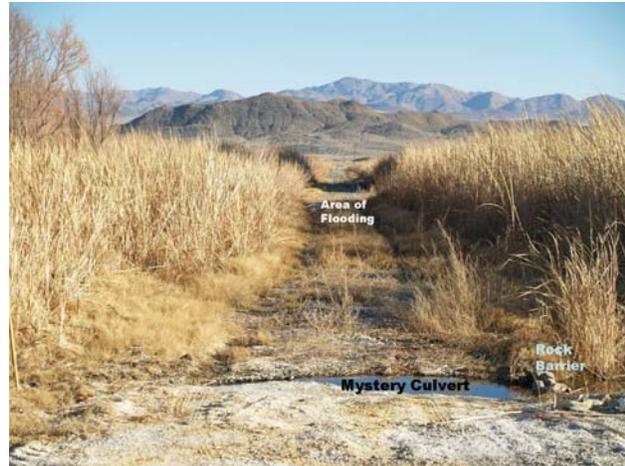
Figure 19: Mystery Culvert and portion of railroad bed being covered by water.

Work began on 28 August 2006 and finished on 15 September 2006 (Enclosure 1). Susan Williams, an Epsilon Systems contract biologist, monitored the project to ensure that all USFWS mandates were adhered to. During construction the Mystery Culvert fully collapsed, blocking water flow to Lark Seep. In order to alleviate this problem, a ditch was dug across the railroad bed to allow flow to the west side. A rock barrier was constructed along the east bank of the culvert, which allows water flow but restricts the movement of fish. Due to the change in water flow at the Mystery Culvert, the railroad bed between the Mystery Culvert and the Lark Seep Culvert is gradually being flooded (Figure 19). This area will be monitored to document further changes.
